# Land Rover Range Rover IV - airbag indicator lamp on

| Vehicle model | Range Rover IV (LG) |

## Land Rover Range Rover IV airbag indicator lamp is on and fault or error codes relating to the airbags can be set.

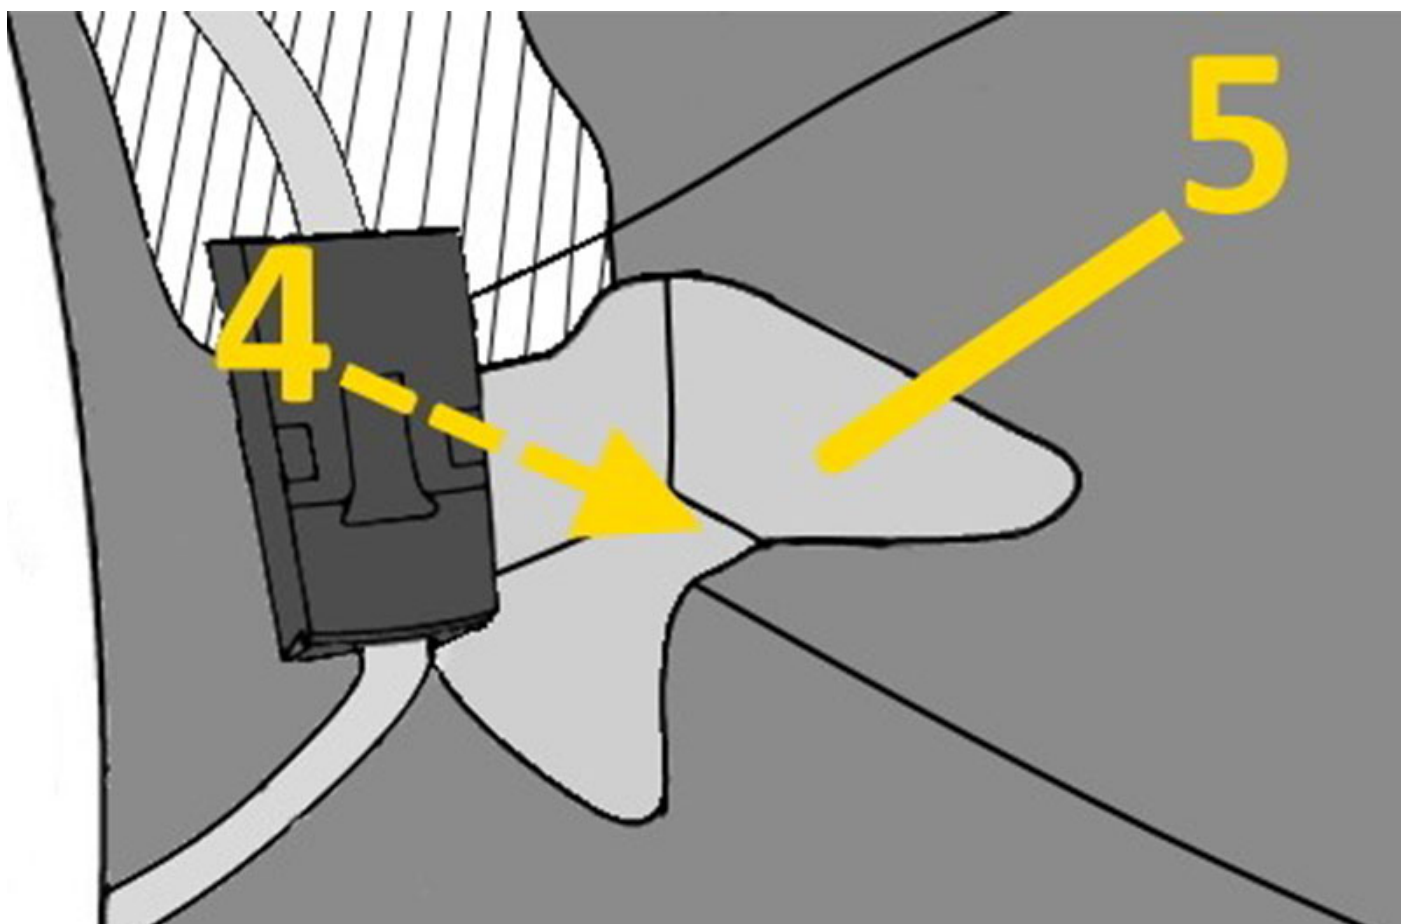
Picture 2: cut-out area in the seat backrest upholstery

- Dismantle cover of the seat backrest
- **Define the marked area ([Figure 1 position 2](#)) of the seat backrest upholstery**
- **([Figure 1 position1](#)) and cut it out with a suitable tool (e.g. a cutter knife)**
- **Check plug connection ([Figure 1 position 3](#)) for correct fit**
- Position the plug connection in the cut-out area
- **([Figure 2 position 4 and 5](#)) and fix, ensuring connection is relieved of strain**
- Fit cover on seat backrest
- Unlock the airbag system
