# **Skoda Octavia - Vehicle not starting up | HELLA**

**Skoda Octavia**

**All models with 2.0 TDI engine**

**Engine code BMN**

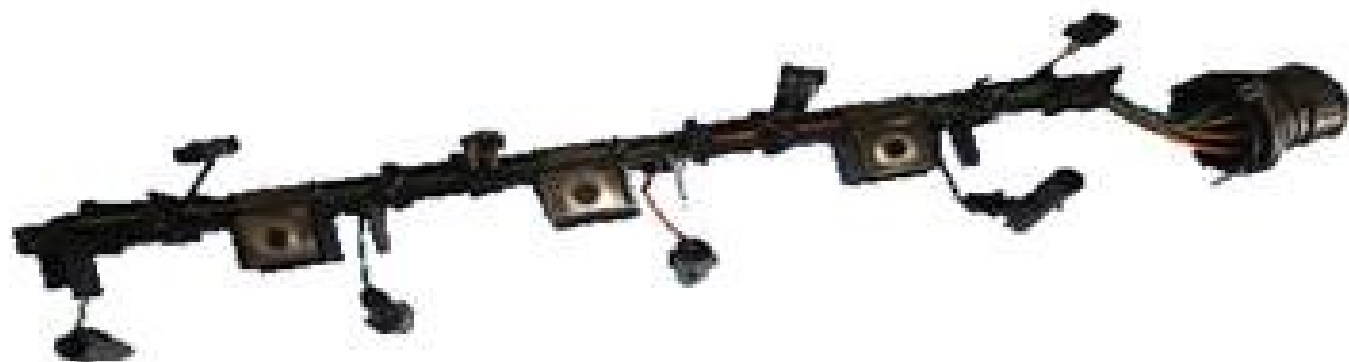
Fig.3

After replacing the defective injection valve you should check that the endstages in the electronic control unit (Fig.2) are functioning correctly and check the injector cable harness (Fig.3) for possible cracks or damaged contacts. To avoid further damage, when an injector valve fails it is advisable to check, and if necessary replace, all the other injector valves that have the same code number, because it can be expected that these may be the next to fail.

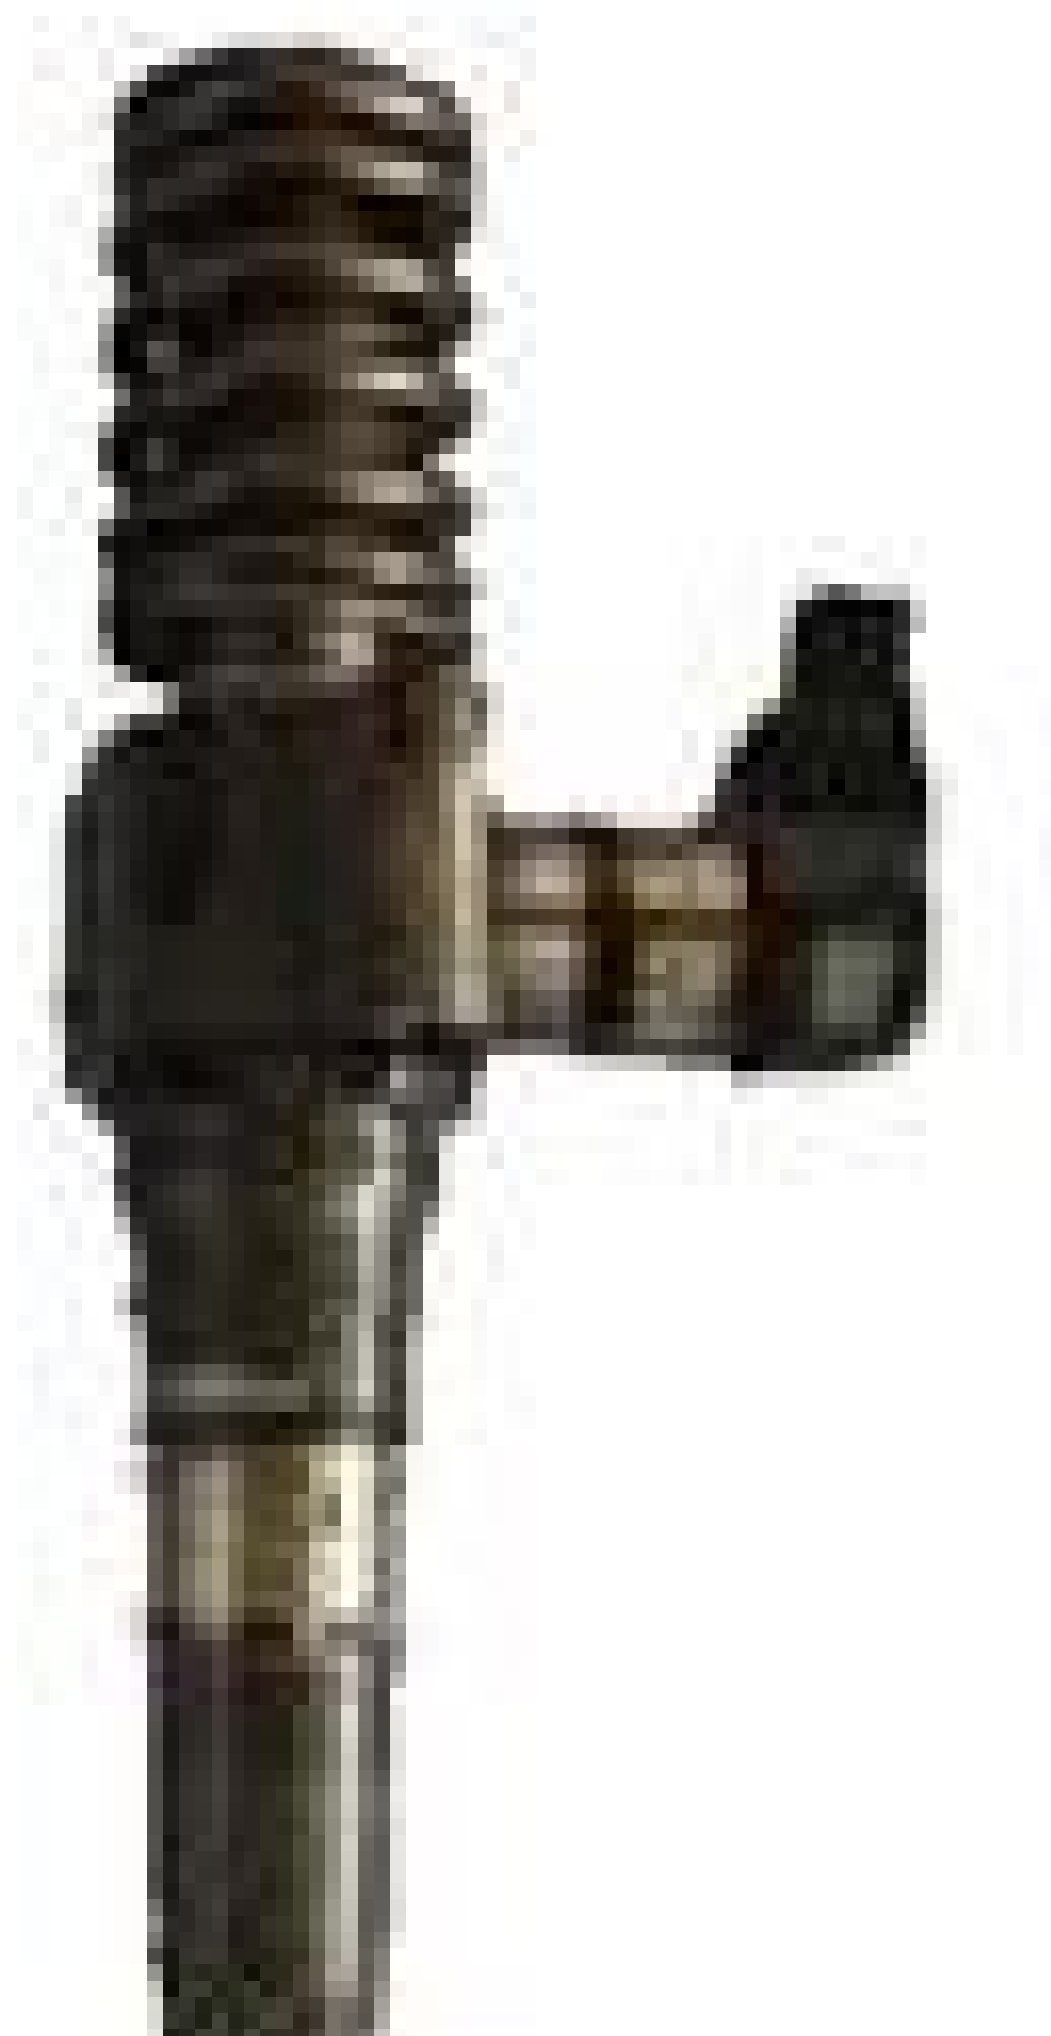
If this deficiency is detected in connection with the above error codes, it may be caused by a short-circuit in an injection valve (Fig.1).
