Suzuki Alto - Value displayed on coolant temperature gauge is too low | HELLA

Suzuki

Alto

All models: 2002 to 2007

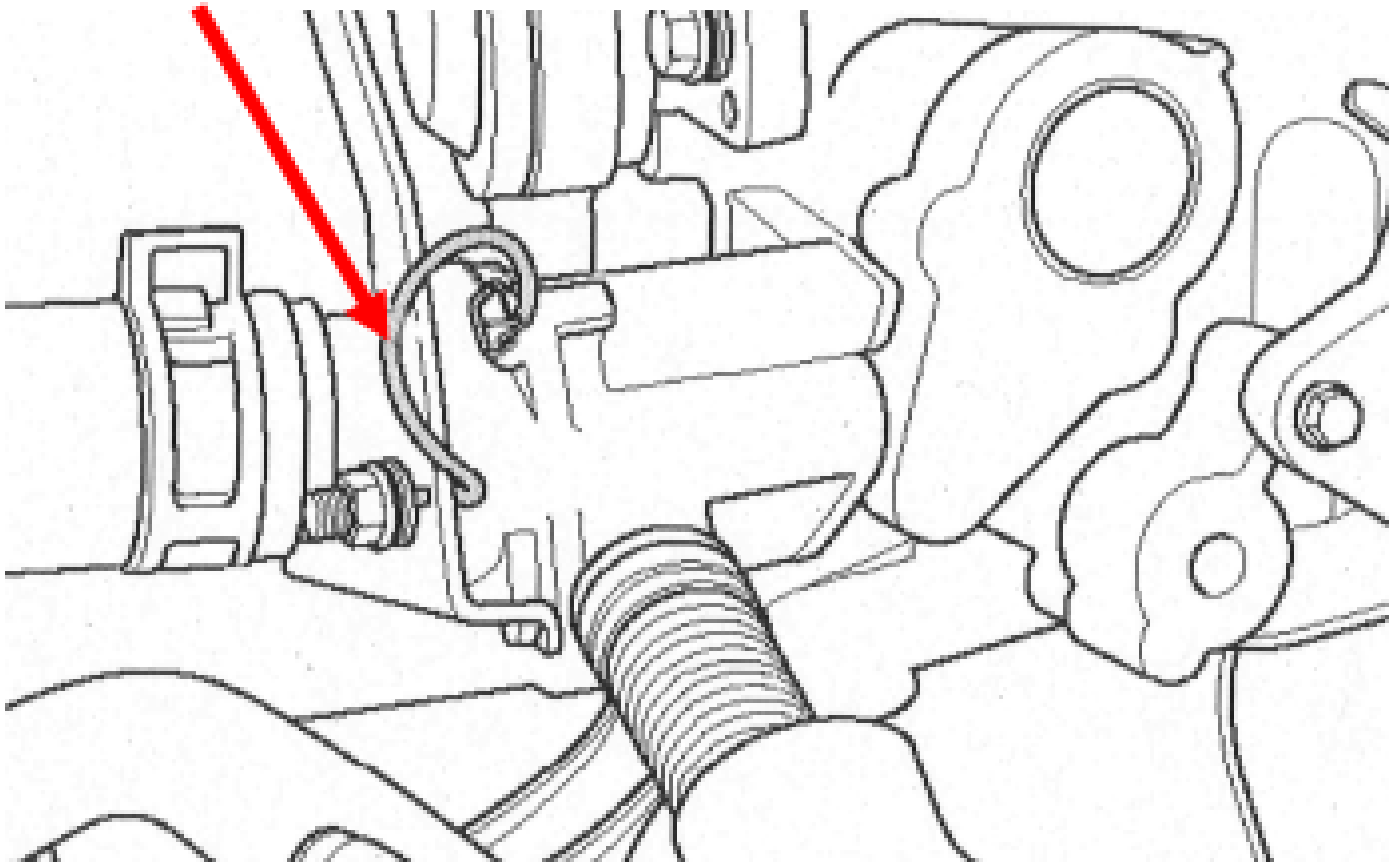
Value displayed on coolant temperature gauge is too low.

If these vehicles display an irregular coolant temperature value, the possibility of a bad ground connection to the thermostat housing bracket must be considered. To fix this problem, the ground cable (see figure) should be connected between the thermostat housing and the thermostat housing bracket.

Additionally, check the thermostat housing for damage and replace if necessary.

1 unit: Ground cable: 39313M82020

1 unit: Fastening bolt: 02142M05123
