# **VW Golf 6 Plus - Poor acceleration performance | HELLA**

**VW Golf 6 Plus**

**Model year 2010-2014**

**Poor acceleration performance**

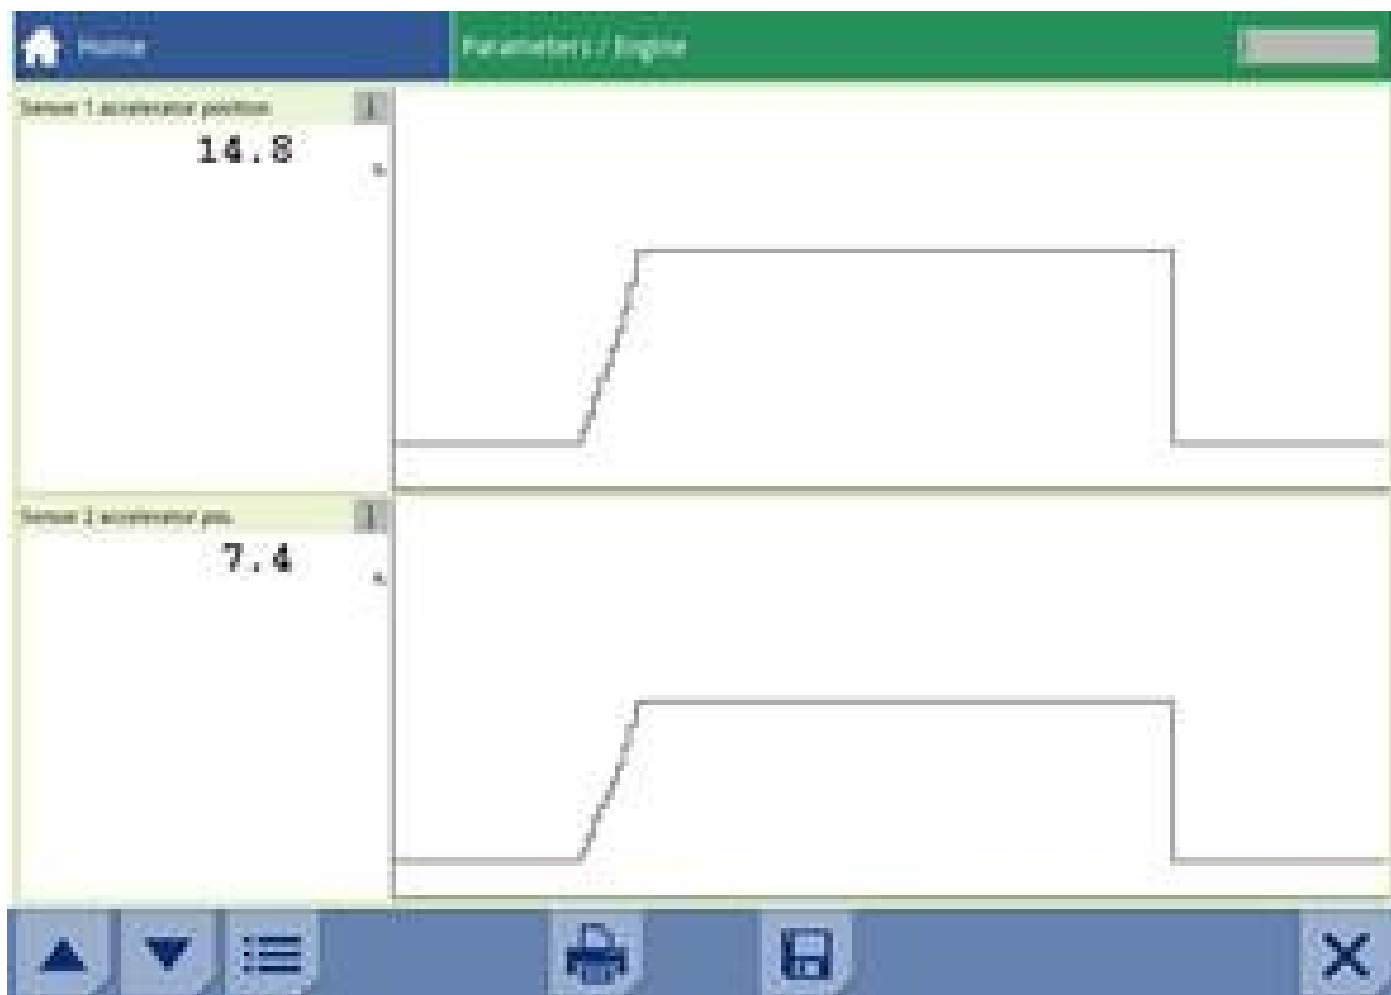
Example: parameter display in mega macs 66 diagnostic unit. Error-free signal curve following confirmation of accelerator pedal sensor

- Unplug accelerator pedal sensor connector on the wiring harness side and check for loose or defective individual connectors. Repair or replace defective components
- Check accelerator pedal sensor for proper functioning. Also display and analyze signal curve in diagnostic unit or oscilloscope
- Delete error memory entries and do test drive.
