Vauxhall Corsa C - Instrument display with intermittent loss of function | HELLA

Vauxhall Corsa C

Instrument display with intermittent loss of function.

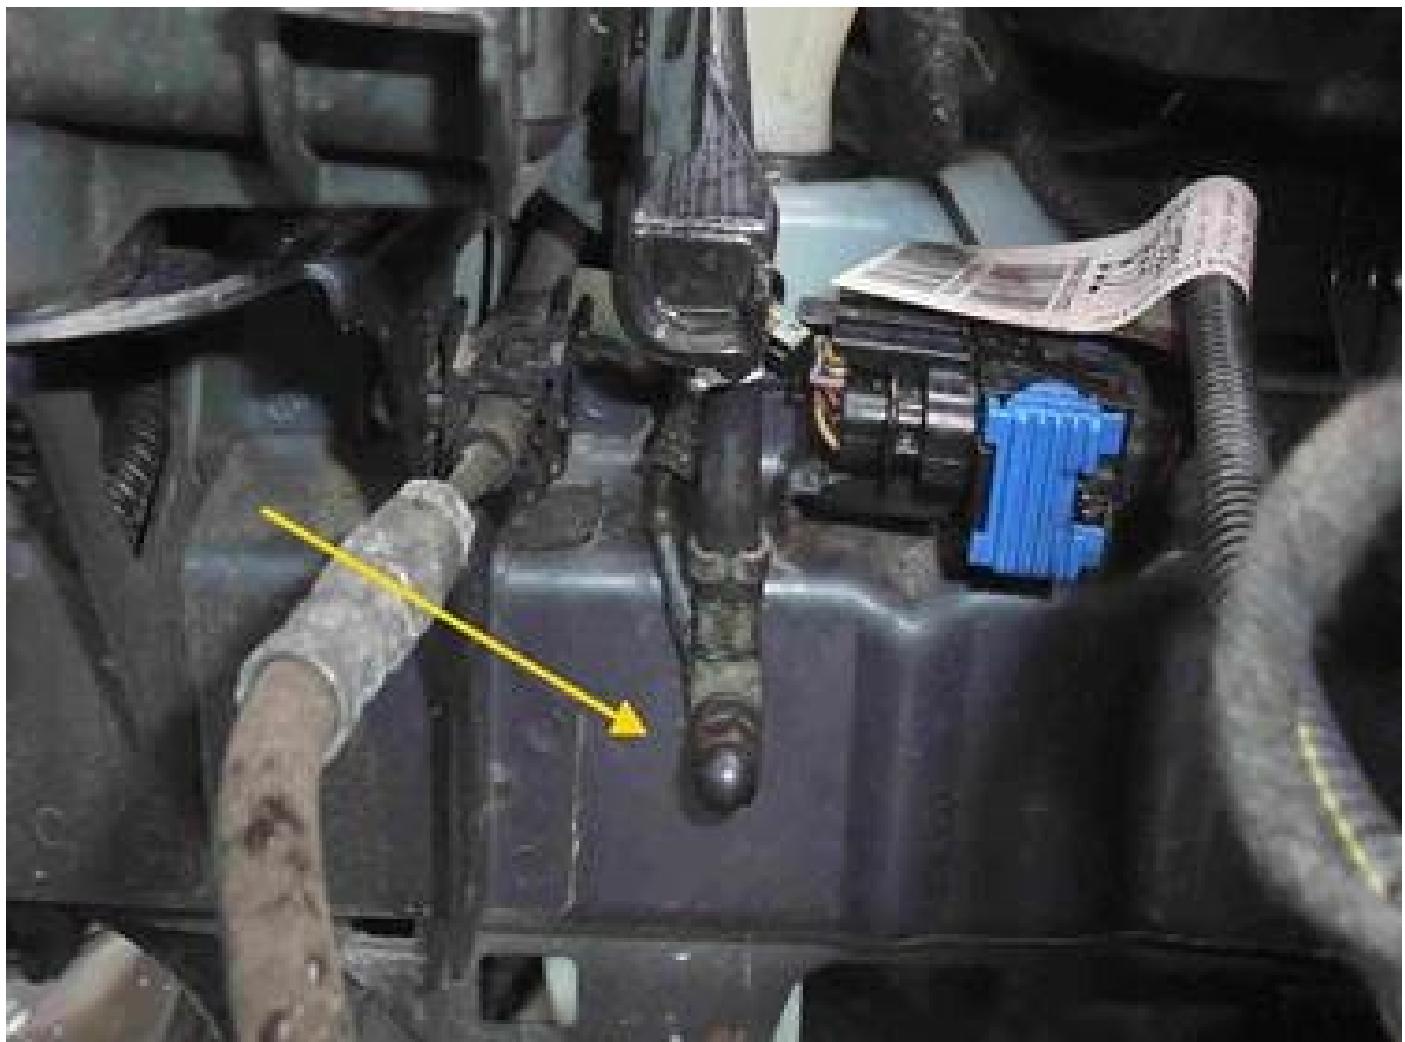
If a malfunction or intermittent failure of the instrument display (which remains until the next ignition cycle) while driving is complained at for these vehicles, a possible source of fault is the earth connection.

Check the chassis earth point in the engine room (see photo). Check here that the cap nut is tightened and the cable connections are corrosion-free and tight.

If the earth cable connections are loose, install an additional spring washer/circlip to secure the attachment of the earth connection.
