# Vauxhall Insignia - rasping noise from the engine compartment when load is changed

| Vehicle model | Insignia A |
| Engine | 1.6i 16 V |
| Engine code | A16 LET |

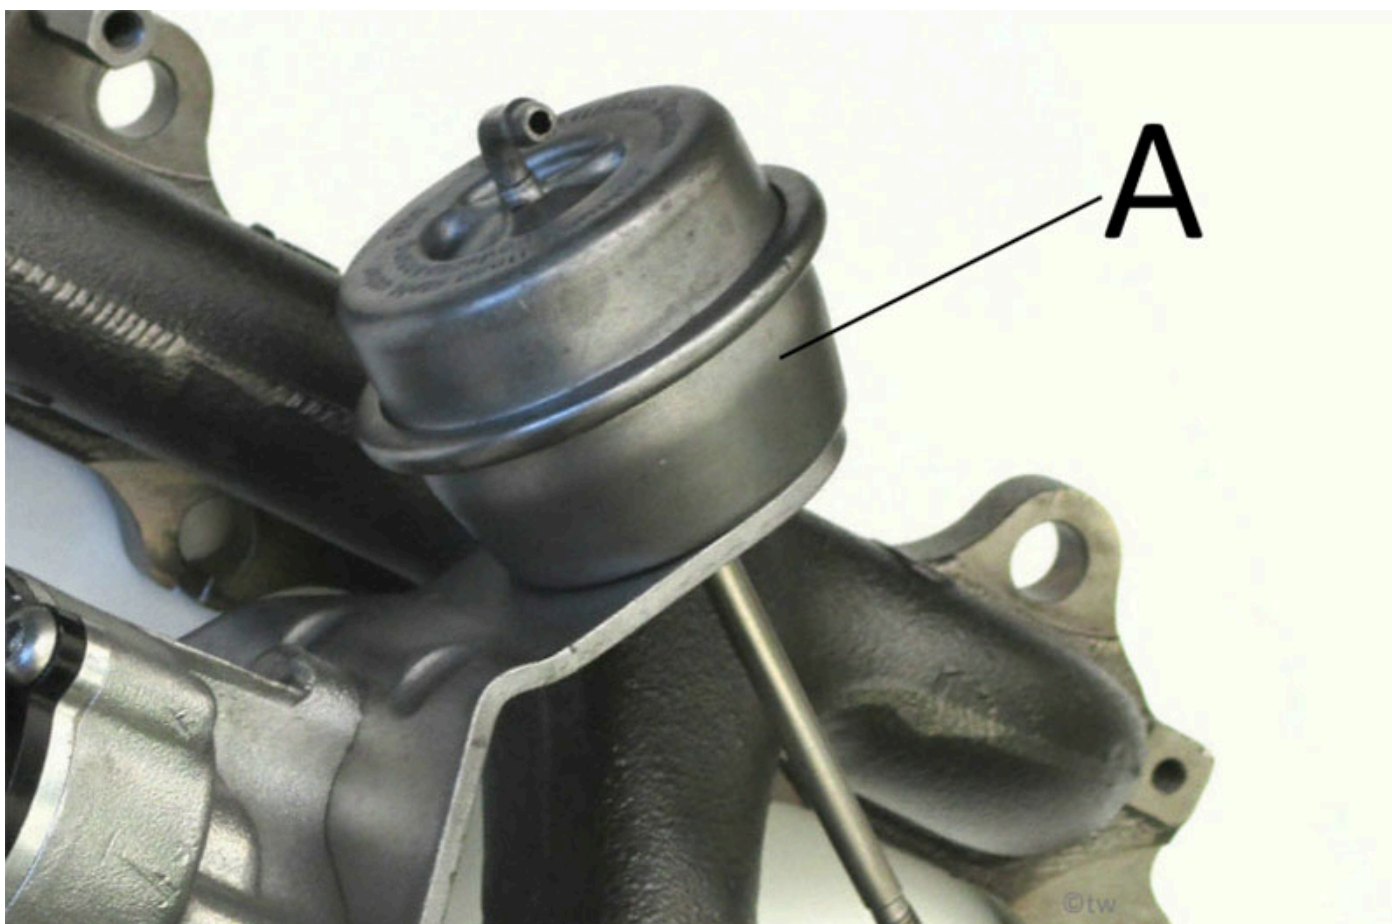
If the above-mentioned defect is detected, it may be related to a defect in the vacuum system responsible for controlling the turbocharger.

The vacuum box on the turbocharger actuator (A) is connected to a vacuum tank via vacuum lines and valves. Leaks caused by ageing or component defects can lead to faulty controlling, which triggers the rasping sound.

In such a case, the vacuum system should be tested with an installed vacuum hand pump.

If the test shows that the vacuum is leaking of its own accord, the defective components are to be replaced.
