# **Volvo V60 (155/157) - Service connection of the air conditioning system | HELLA**

**V60 (155/157)**

**Model year: 2010 - 2018**

## **Service connection of the air conditioning system**

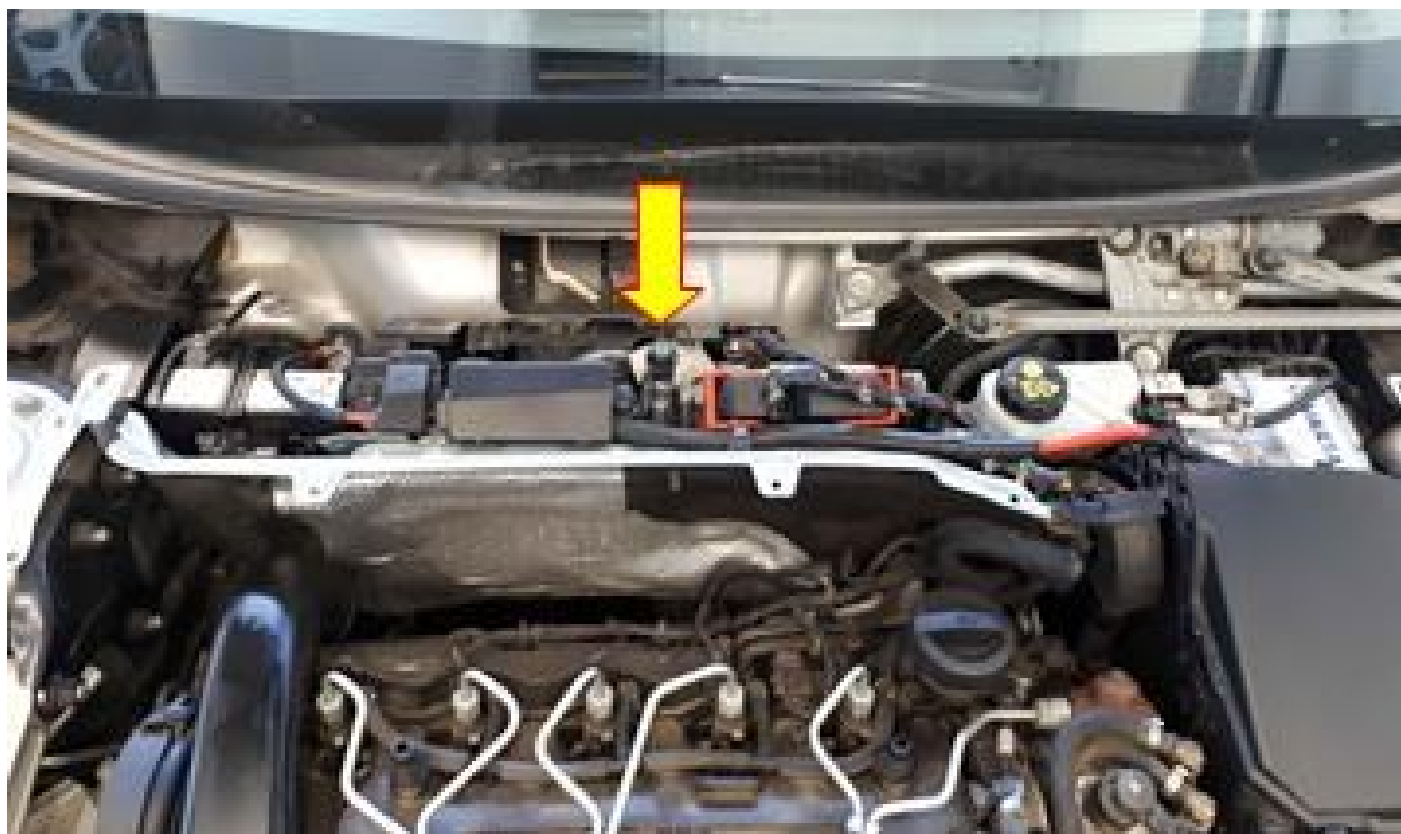
The service connection is now visible in the middle of the water tank (Fig.1+2).

If the low-pressure service connection of the air-conditioning system in the engine compartment is not immediately visible on the above-mentioned vehicle, it can be found located below the water tank cover (cowl cover).

- Dismantle wiper arms
- Remove fastening plug of the cowl cover
- Remove cover
