Audi TT - Condensation in the headlamp | HELLA

Audi TT

Model year: 2006 - 2014

Condensation in the headlamp

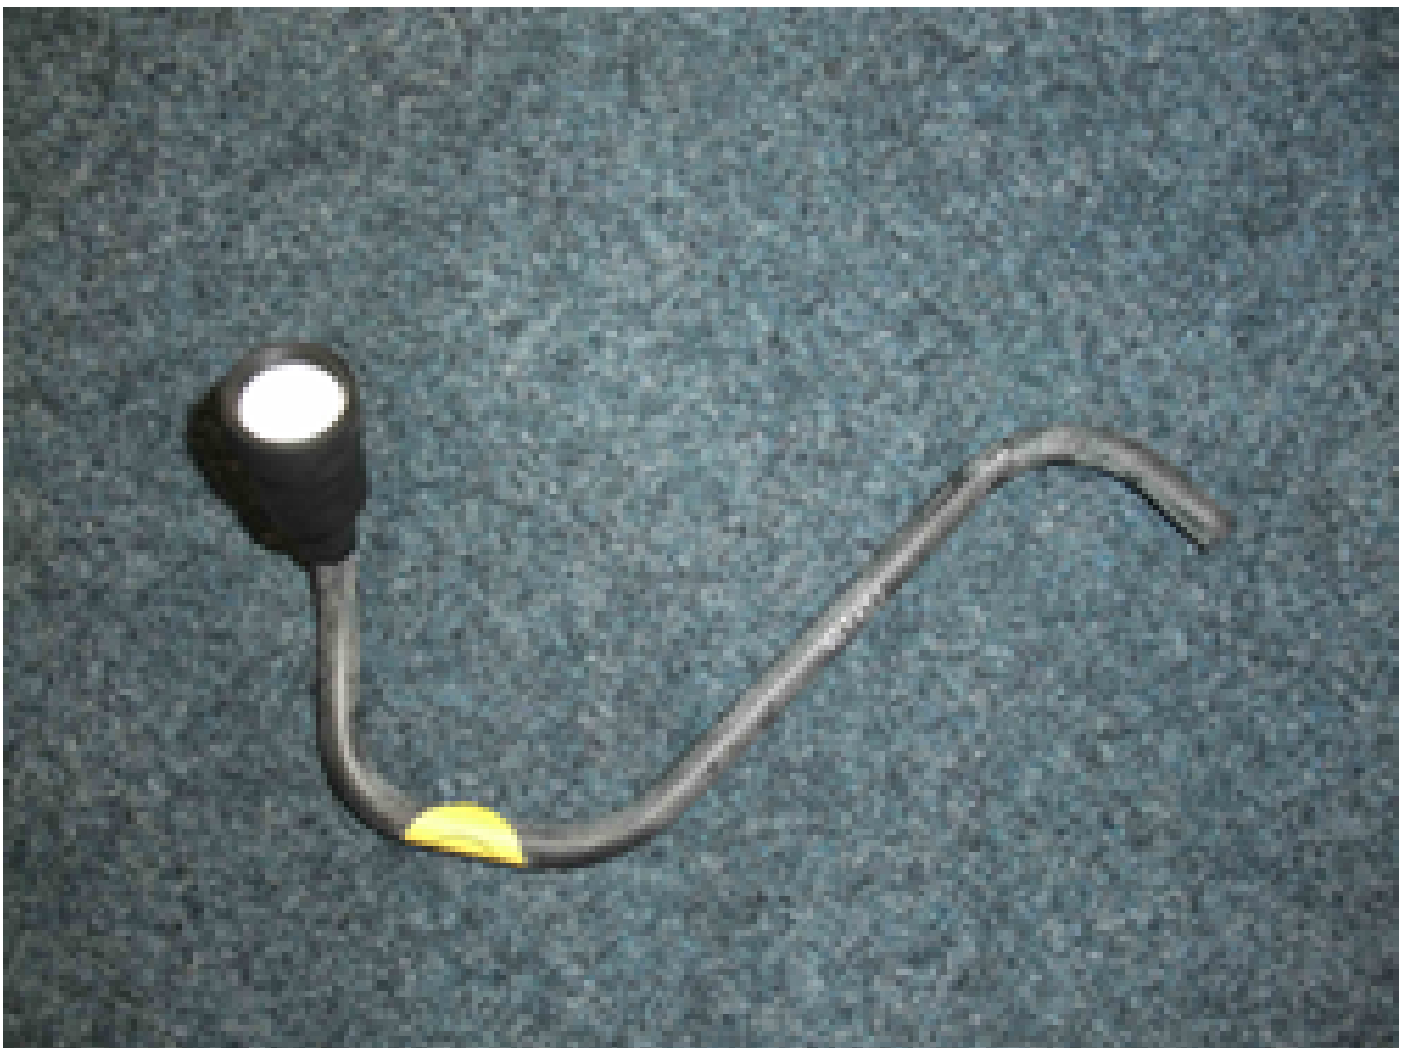
Fig.1

If the above-mentioned vehicle is found to have an extreme amount of condensation forming in the headlamps, the cause might be water entering through the ventilation hose.

In order to combat this, the vehicle manufacturer offers a modified hose, (Fig.1 / Fig.2), which is intended to reduce the high level of condensation. Another feature of this hose is that its shape governs the mounting position.

Parts no.: ventilation hose

Left: 8J0 941 717 B

Right: 8J0 941 718
