# Mercedes W210 - Replacement starter is not functioning | HELLA

**W210 (E-Klasse)**

## **Replacement starter is not functioning**

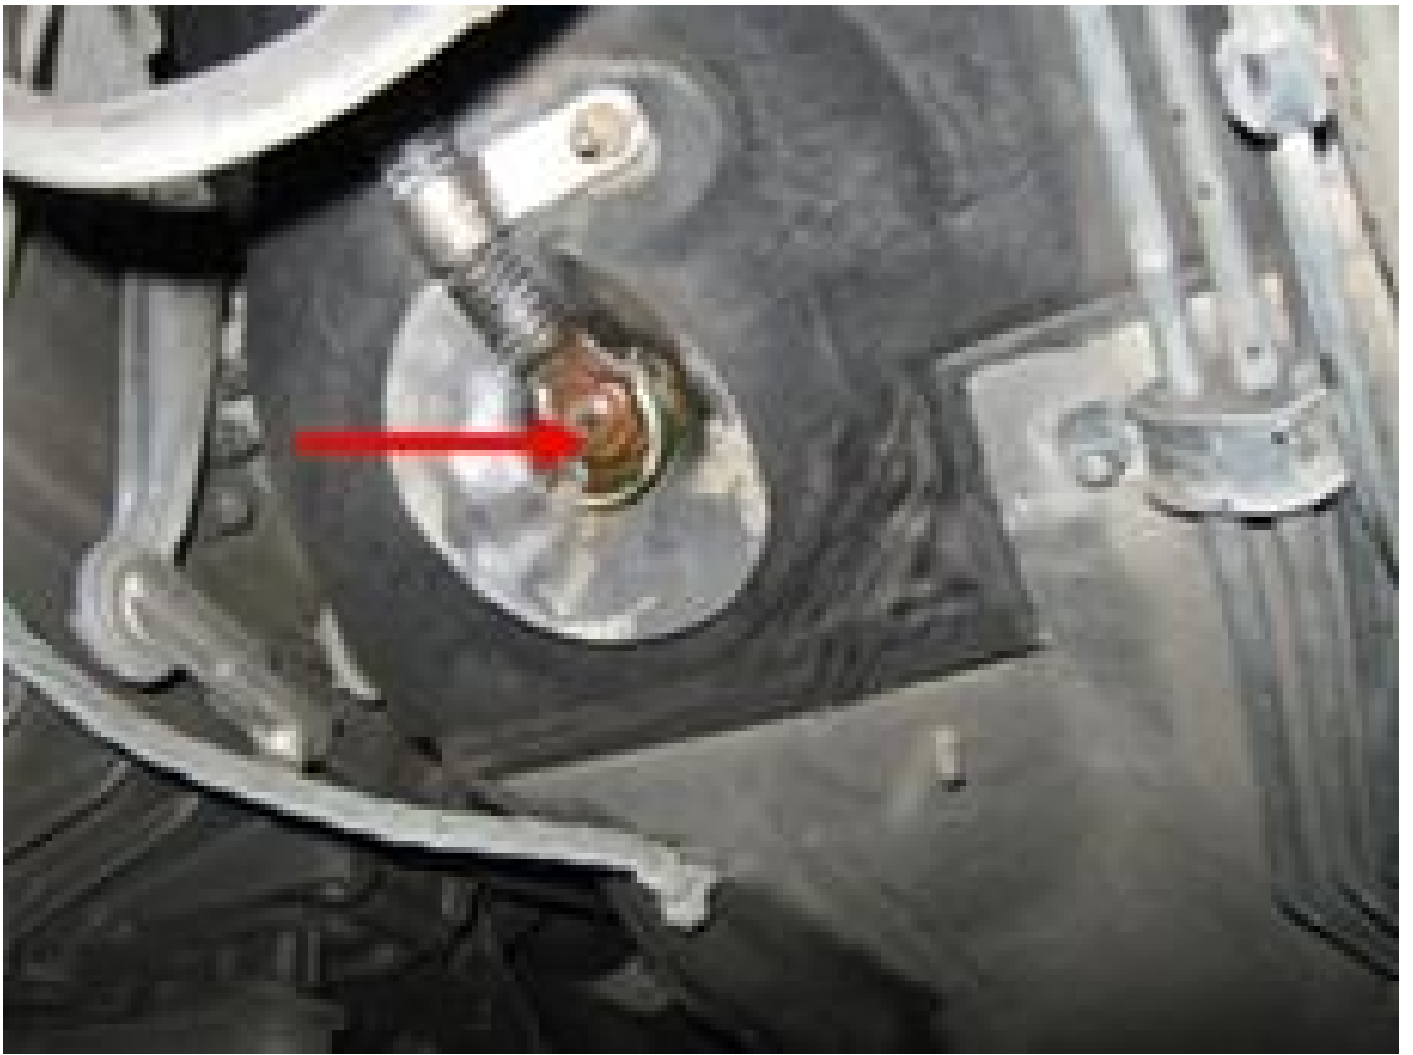
Figure 1

When removing the starter, it is sometimes necessary to disconnect and then reconnect the positive battery cable connector on the undercarriage of the vehicle (Figure 1). At that time, the other side of the connection (in the vehicle interior, Figure 2) may come loose, which causes an interruption in the power supply. Consequently, the vehicle will not start and it will seem as though the starter is not functioning.
