Vauxhall Astra J - Airbag indicator lamp lights up | HELLA

Astra J

Airbag indicator lamp lights up

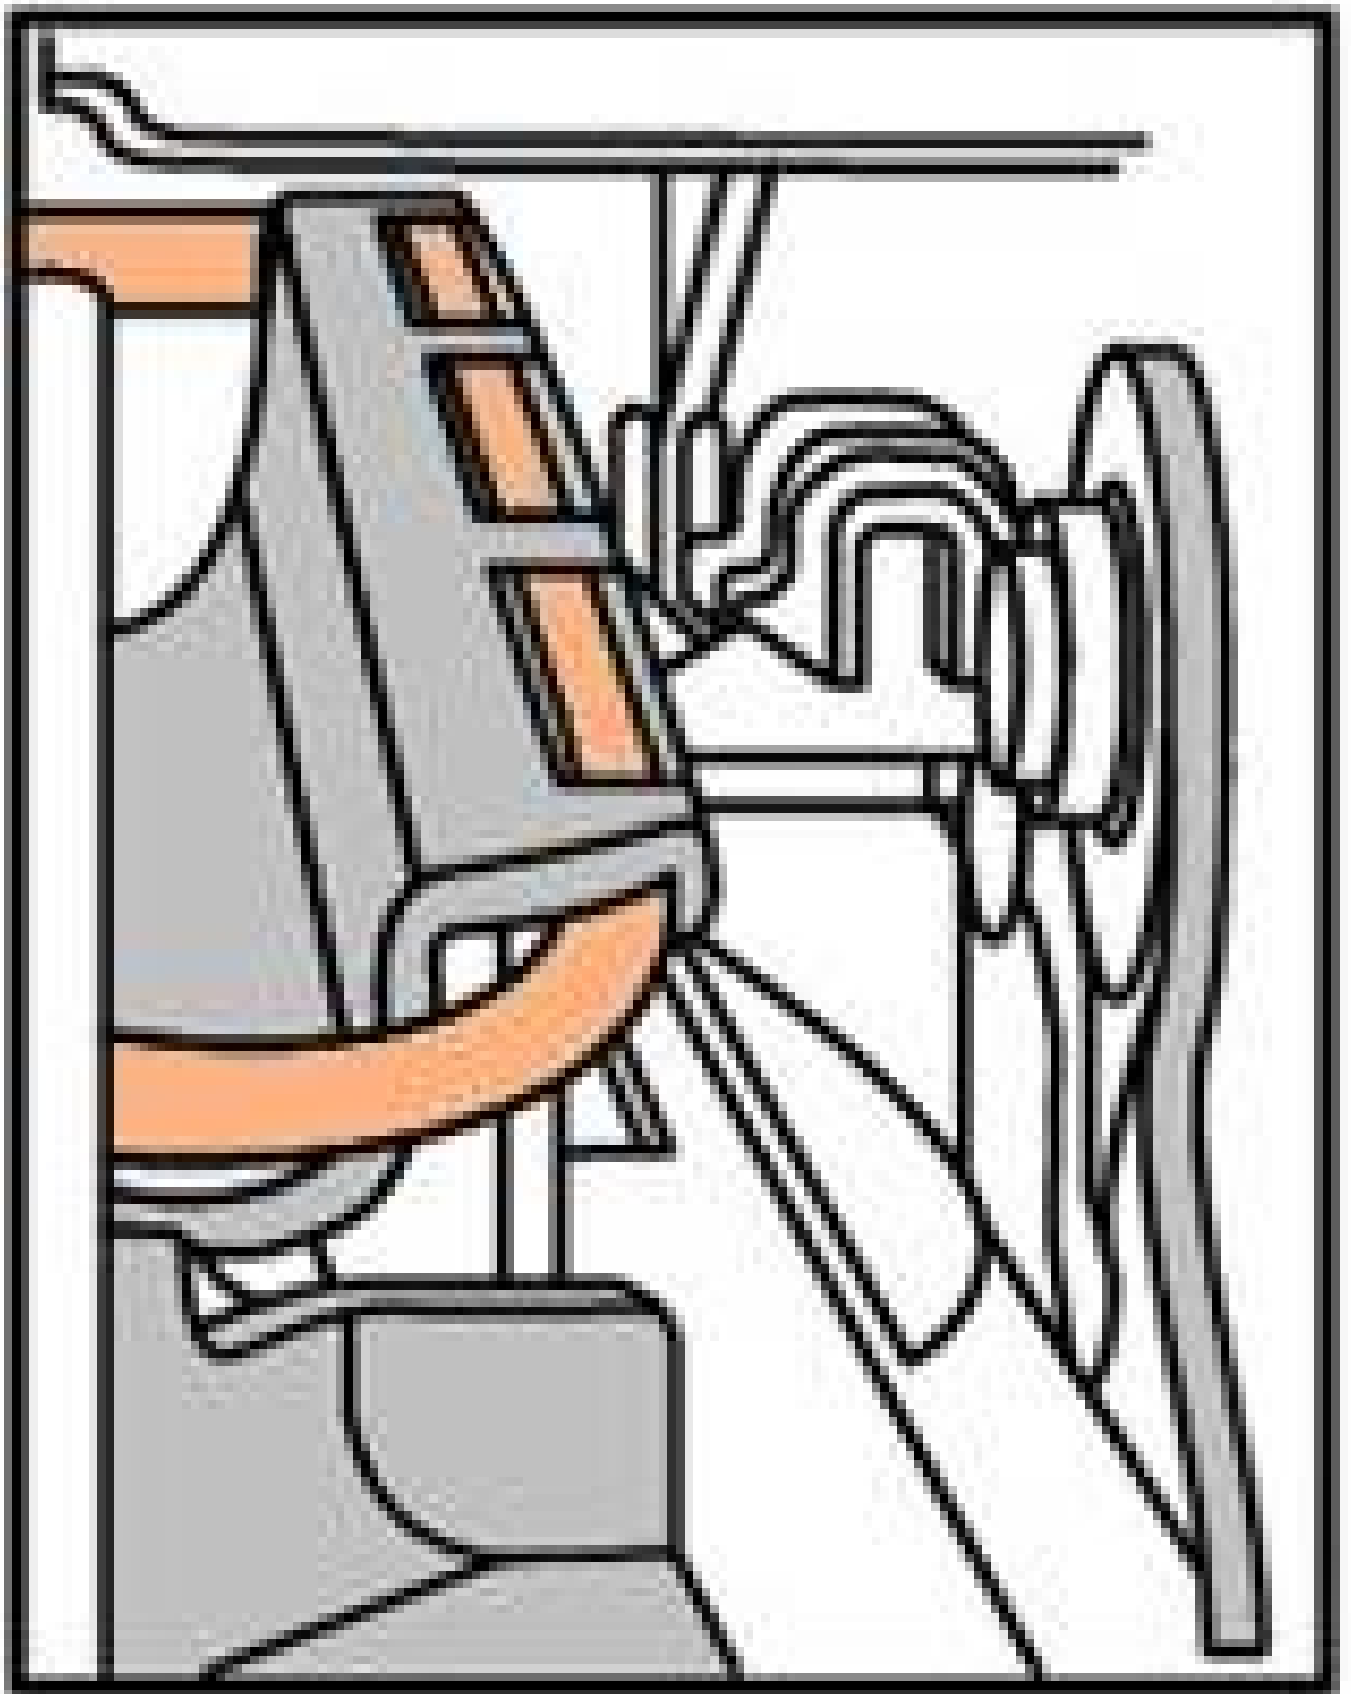
Figure 2

(make sure the cable strand is correctly installed)

- Replacing the belt tensioner unit
- Re-installation and fastening of the cable strand

- Replacing the seat rail cover

- Finally, read out and erase the error memory
