# Volvo XC 40 - replacing the pollen filter/cabin air filter

## Repair instructions for the pollen filter/cabin air filter

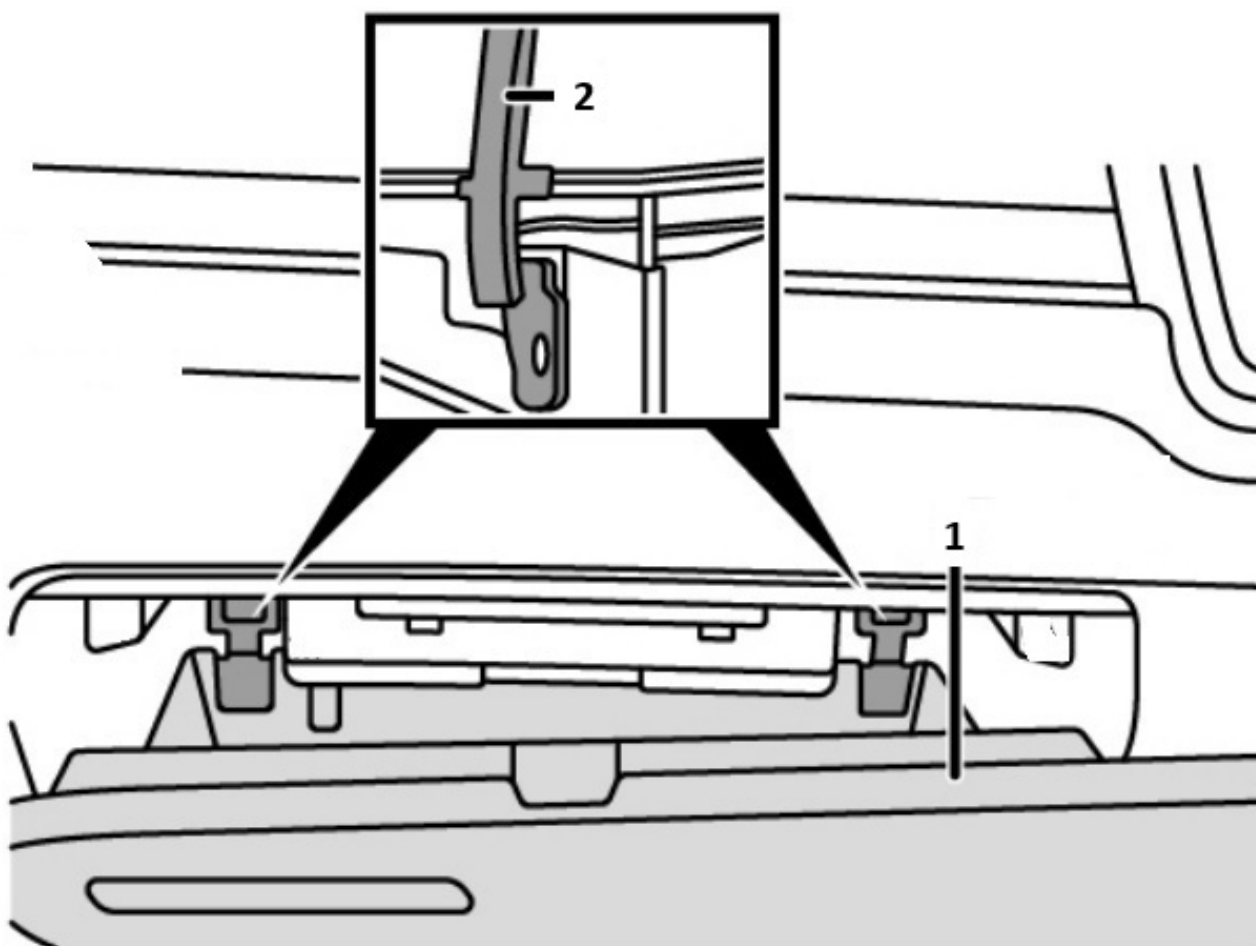
- Open the glove compartment (1) and release the retaining straps (2) so that you can lower the glove compartment lid.
- By unlocking the locking tabs(3), you can remove the cover (4) to release the latch (5). The cover (6) can now be opened.
