# BMW 2 Series Active Tourer - changing the cabin air filter

| Vehicle model | 2 Series Active Tourer (F45) |

## Pollen filter replacement for the BMW 2 Series Active Tourer

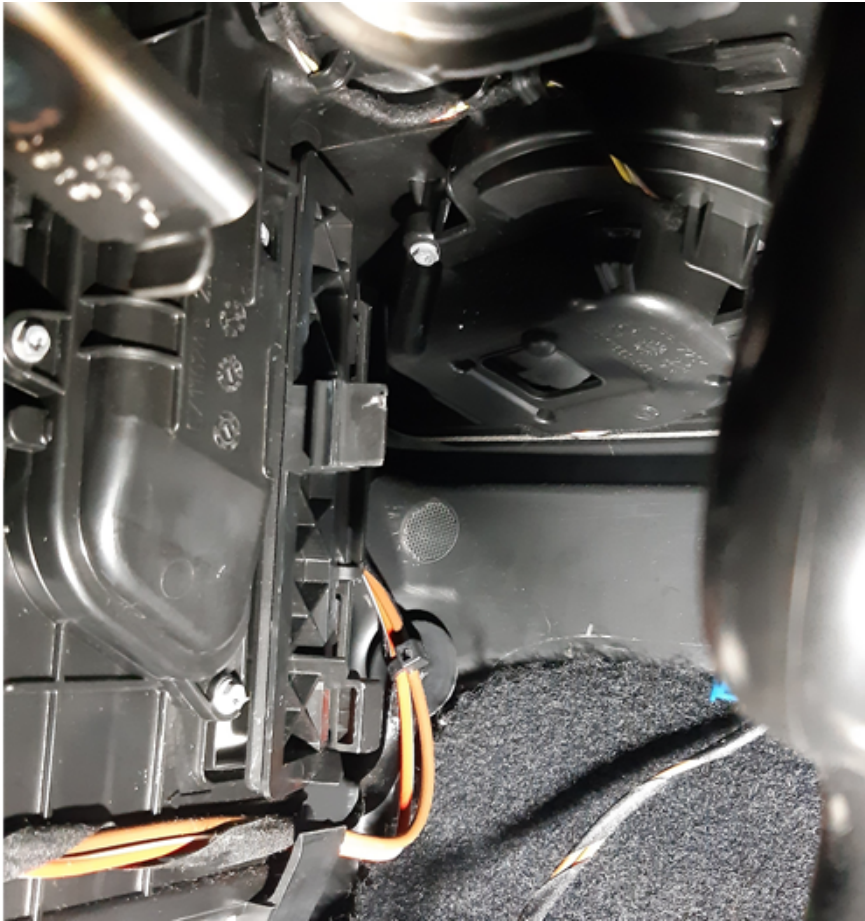
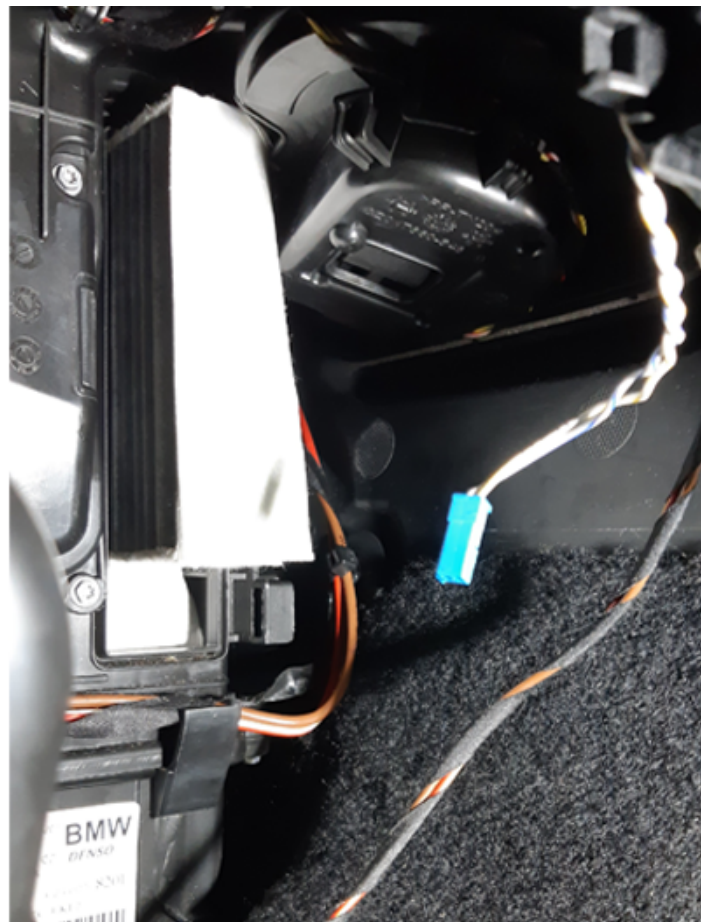
- Figure 1: Remove the trim in the footwell on the passenger side by first of all removing the screws (2x).
  - Figure 2: Remove the left cover in the footwell on the passenger side, again by first removing the two screws
  - Figure 3: Remove the air outlet by removing the screw (1x) and pulling the air outlet to the right
  - Figure 4: Pull off the hose from the heating/air-conditioning housing to the right
  - Figure 5: Unlock and remove the cover from the heating/air-conditioning housing
  - Figure 6: Pull out the cabin filter
- In order to install the new filter, proceed as above but in reverse order.
