VW Passat - whistling noises during acceleration

Manufacturer	VW
Vehicle model	Passat 3G2/3G5
Engine	2.0 16 V TDI
Engine code	DFGA / CRLB
Year of manufacture	2014-2019
Symptoms	Exhaust system whistles during acceleration

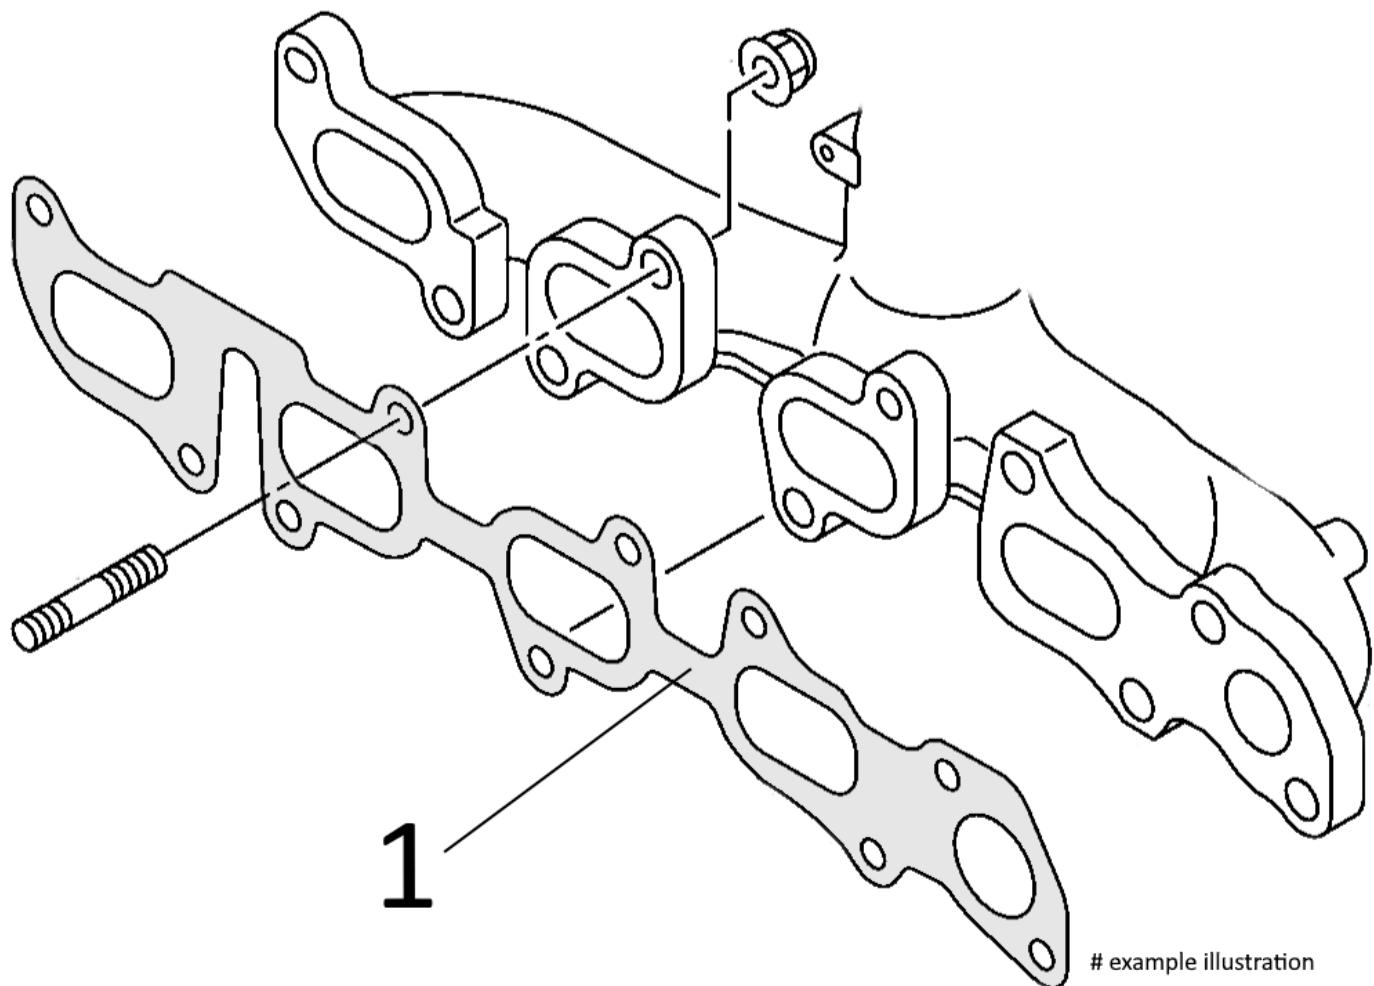
Figure 1

If whistling noises are detected coming from the area of the exhaust system during acceleration, a possible cause may be a defective gasket on the exhaust manifold.

In certain cases, leaks may occur on the sealing surfaces of the first and fourth cylinders as a result of the vehicle design. If no other defects are found in the exhaust system during the fault diagnosis, the seal (1) should be checked and replaced if necessary.

- Visual inspection of the exhaust manifold to check for leaks
- Removal of the exhaust manifold and thorough cleaning of the sealing surfaces
- Installation of the exhaust manifold with new gasket and new fastening nuts

- Exhaust manifold gasket: 04L 253 039G
- Fastening nut: N 908 946 01
