## Toyota Avensis (T22)

### Starter/ignition without function

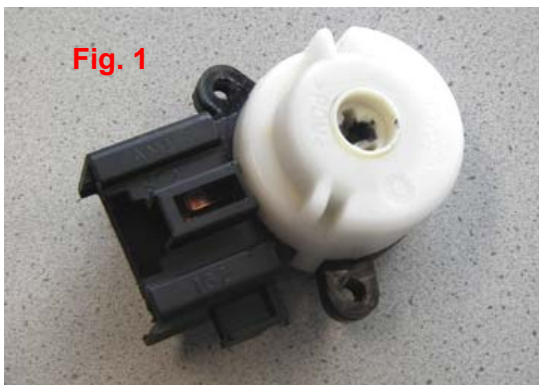
With the above-mentioned vehicles it can occasionally happen that the ignition does not switch on or the starter is not triggered when the key is turned. It is often possible to start the vehicle after turning the ignition key backwards and forwards a few times. Usually, this problem is caused by a faulty contact part (Fig. 1) on the ignition lock. To replace the contact part proceed as follows:

- Remove the trim in the footwell on the driver's side
- Remove the lower steering wheel skirt. To do this, loosen the three attachment screws. To reach two of the screws, the steering wheel has to be turned through 90° out of centre to the right and left respectively
- Remove the plug-type contacts of the wiring from the contact part
- Remove the contact part by taking the two attachment screws out (Fig. 2)
- Install a new contact part and replace the trims in reverse order
- Carry out a functional test
