## **BMW 3 Series (E46) All vehicles with fog lights**

### **Fog lights illuminate poorly**

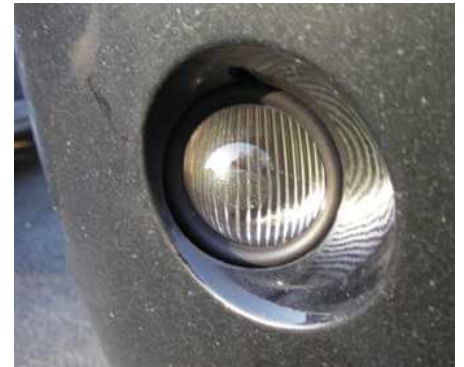
Fig. 2

If there are complaints about the above-mentioned fault, the cause could be corroded reflectors. Heavy and permanent fogging can give rise to the formation of corrosion in the fog lights (see Fig. 1). Due to this, the luminous efficiency of the light is critically reduced and the above-mentioned complaint arises. In this case, the complete fog light must be replaced. As an alternative to the original light, the Hella Micro-DE fog light can be installed (part no. 1NL 008 090-031). This is a particularly good idea, as the Hella lights fit into the openings for the original lights (see Fig. 2).
