Alternators with heavily oil-fouled vacuum pump

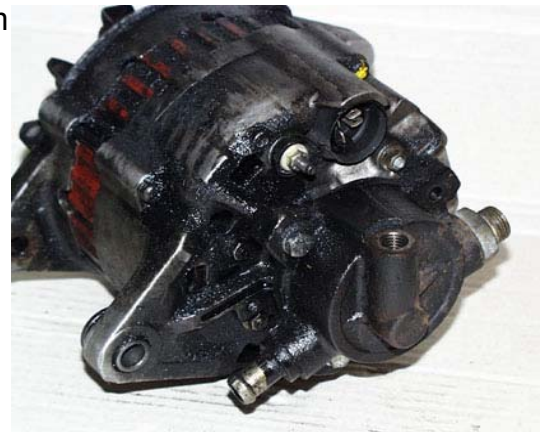
In the case of some vehicles with diesel engines, the vacuum required for the brake booster is created by a vacuum pump fitted to the alternator. A frequently-occurring problem is that these alternators are completely fouled with oil and therefore fail.

One of the most frequent causes of this problem is the seal between the alternator and the vacuum pump. This seal, which is in the main realized via a rubber ring, becomes leaky due to ageing and also after replacement of the alternator. Often, the rubber ring is not replaced, and the alternator fails after a short time due to the entry of oil.

The entry of oil can damage the alternator within a very short space of time, and lead to failure.

The seal between the alternator and the vacuum pump should always be replaced if the components have been separated. In relation to this, also check the oil and vacuum hoses on the vacuum pump for tightness.
